Auger Ref:
12345.1.UCC

Site Based Drainage Validation Report

The Baptist Church, Church Street
Church Town, CH1 2CH

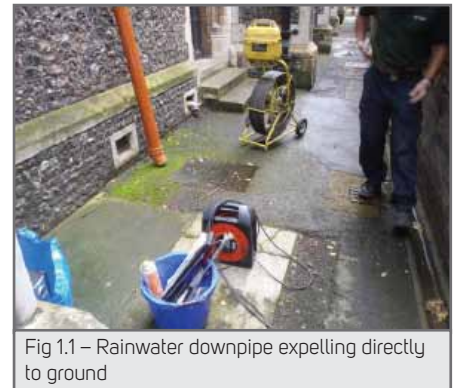
The rainwater downpipes to the left hand side of the church all appear to expel directly on to the ground and not into the surface water system.

Fig 1.1 – Rainwater downpipe expelling directly to ground

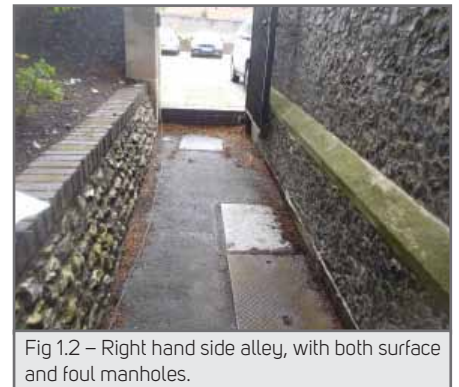
Fig 1.2 – Right hand side alley, with both surface and foul manholes.

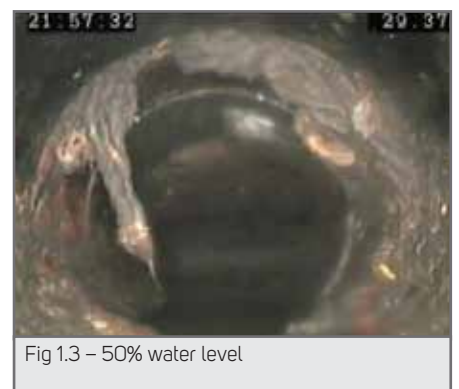
The section of system upstream and downstream from surface manhole 10 was surcharged and holding 50 % water, this part of the system requires extensive jetting to clear the system so a clear CCTV survey can be undertaken to confirm the condition of the pipework.

Fig 1.3 – 50% water level

Cause of problem	Unknown - severely blocked	Insurable?
Insurable defect(s)	Blockage	✓
Proposed solution	Attempt to clear system upstream and downstream from MH10 with Combi Tanker Undertake further investigations	✓ ✓

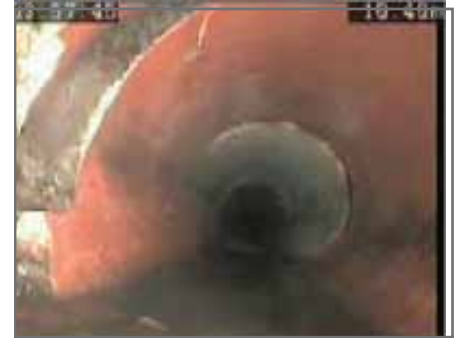
Fig 1.3 – 0.80m = Water level at 20%

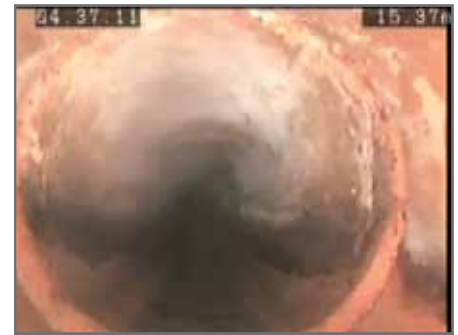
Fig 1.4 – 2.90m = Joint displacement medium

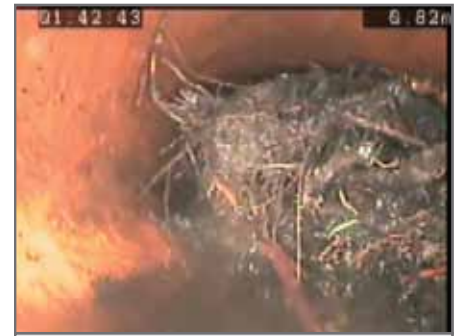
Fig 1.5 – 13.45m = Mass Roots 95% cross sectional area loss
